National Aeronautics and Space Administration

# **Nuclear Compton Telescope Balloon Launch in Alice Springs, Northern Territory, Australia High Visibility Type B Mishap IRIS Case Number S–2010–119–00007 Volume I of II**

**Date of Mishap: April 29, 2010**

**Date of Report: September 7, 2010**

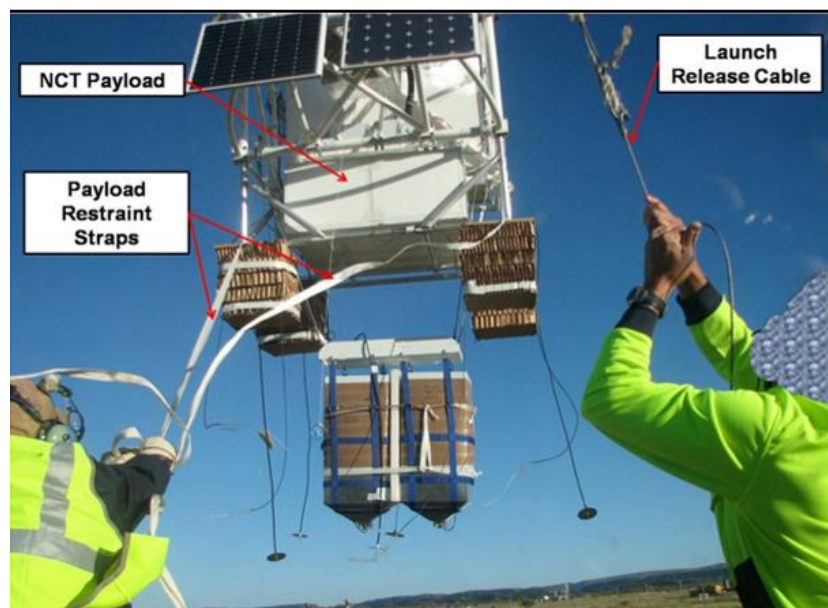
**Figure 20. Actual NCT Launch Attempt**

**Key Event 32:** Approximately 7 sec later, at **PET=86 sec**, the LD instructed the LVD to slow and stop to attempt a launch. When the LD pulled on the launch release lanyard, the launch restraint pin did not release the payload. During this launch attempt, the payload swung out away from the launch vehicle as a result of its inertia, and a team member riding on the launch vehicle with the LD lost hold of the payload controlling straps. The payload continued to swing as the LD tried again to pull the launch release lanyard to release the payload. Again, the payload did not release. The launch attempt, as viewed from the front of the launch vehicle, is shown in Figure 20. By about PET=90 sec, the vehicle was at a complete stop.

After unsuccessful attempts to release the payload, the LD instructed the LVD to proceed forward to try to “catch” the balloon.

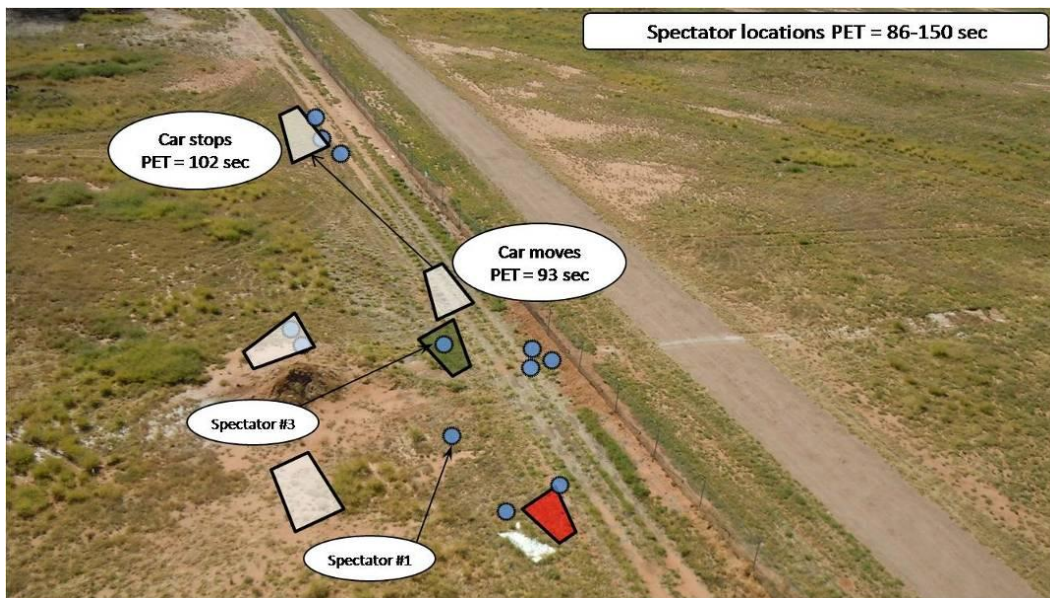
Figure 21. Spectator Location at PET 86-150 Seconds

**Key Event 39:** At about **PET=105 sec**, the launch vehicle arrived at the perimeter fence and stopped. The LD realized that the mission would have to be aborted, but because spectators were in the flight path, did not order an abort. After several seconds at the fence, the LD ordered the vehicle to be backed away from the fence. Spectator locations during this event are shown in Figure 21.

**Key Events 41 through 43:** The vehicle began backing away at **PET=118 sec** and continued backing until about **PET=150 sec**. At this time, the vehicle no longer had traction to continue backing as a result of the tires slipping in the loose soil. At this point, the launch vehicle was still about 150 ft beyond the Category A Hazard Area (fixed interpretation). The LD instructed the LVD to proceed forward and make a left turn in an attempt to move the system away from the spectators. Spectator locations during this event are shown in Figure 21.

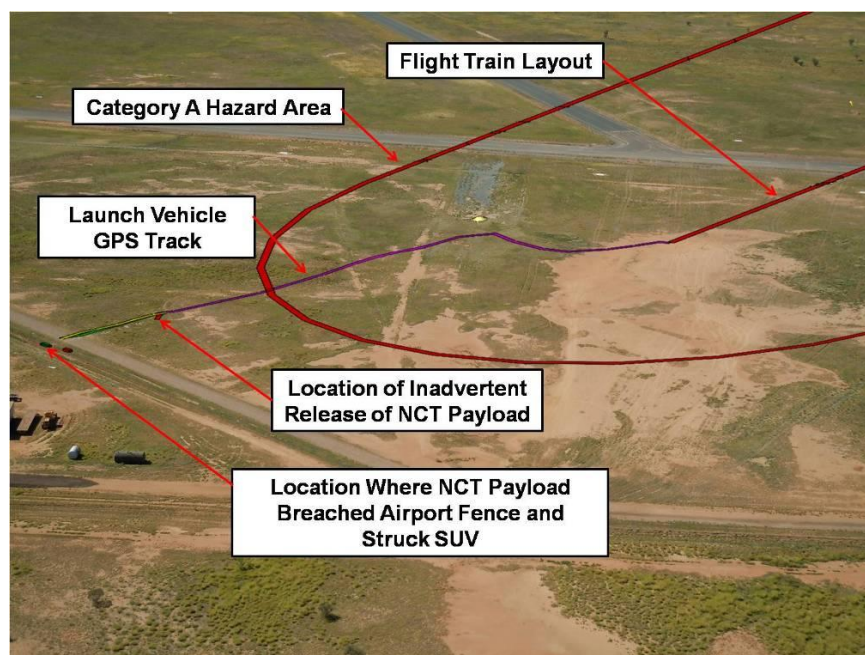
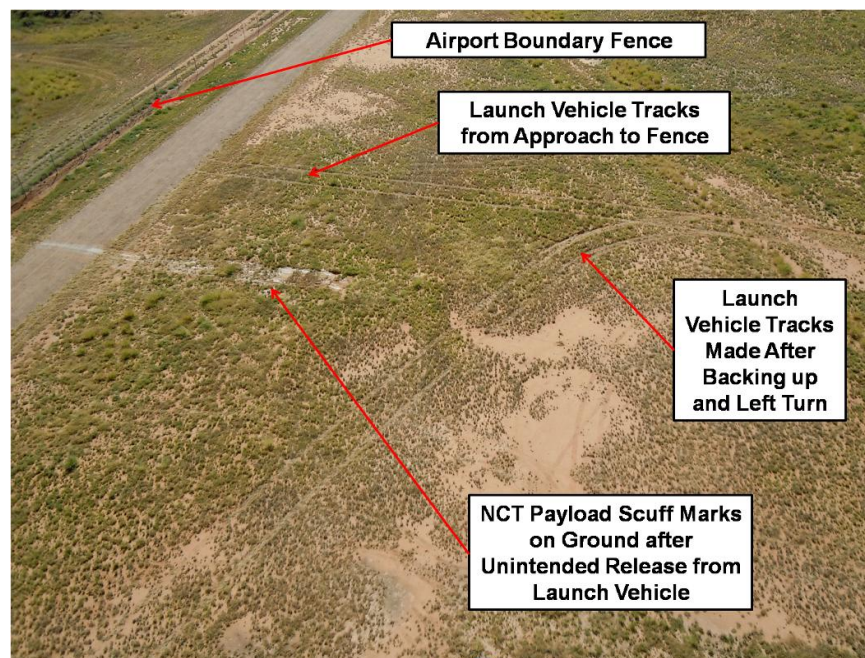
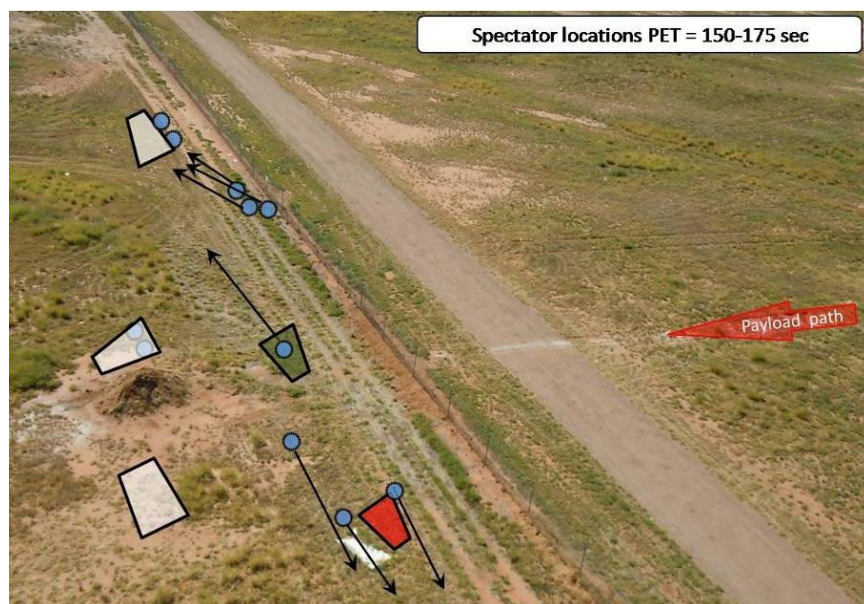
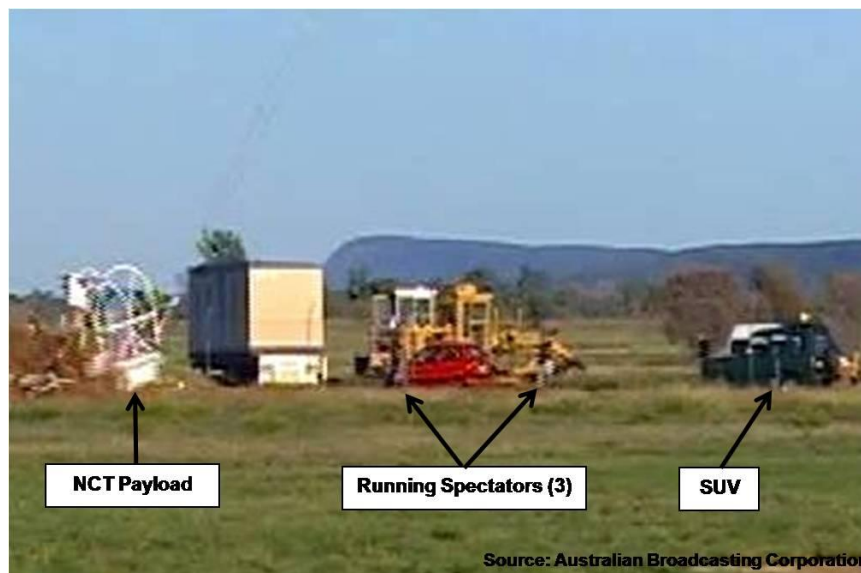
**Key Event 44:** During the left turn, the payload inadvertently released from the launch vehicle at **PET=171 sec**. The balloon pulled the payload downwind, where it breached the Airport security fence and continued moving towards spectators’ cars and spectators who were in the path of the payload’s motion. Spectators were able to run to safety.

During the dragging event, a call was made by the CM to abort the balloon. The mishap site and spectator locations at the time of the mishap are shown in Figures 22 through 25.

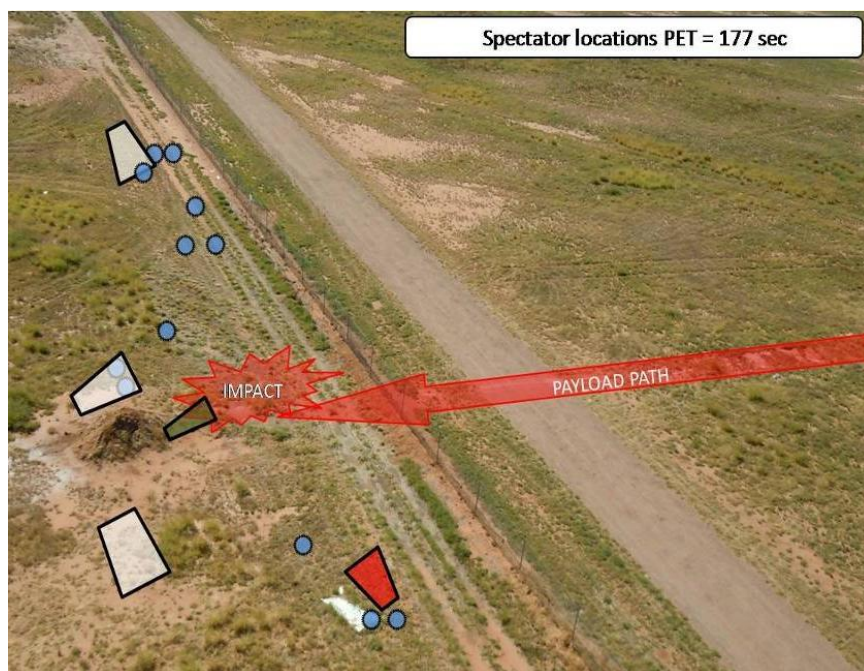
Figure 26. Spectator Location at PET 177 Seconds

**Key Event 47:** At PET=177 s the dragging payload hit a spectator's vehicle. At approximately the same time, the abort command was sent, releasing the balloon from the top of the parachute. After the balloon was separated from the parachute, the payload came to rest. Spectator locations at the time of impact and property damage are shown in Figures 26 and 27.

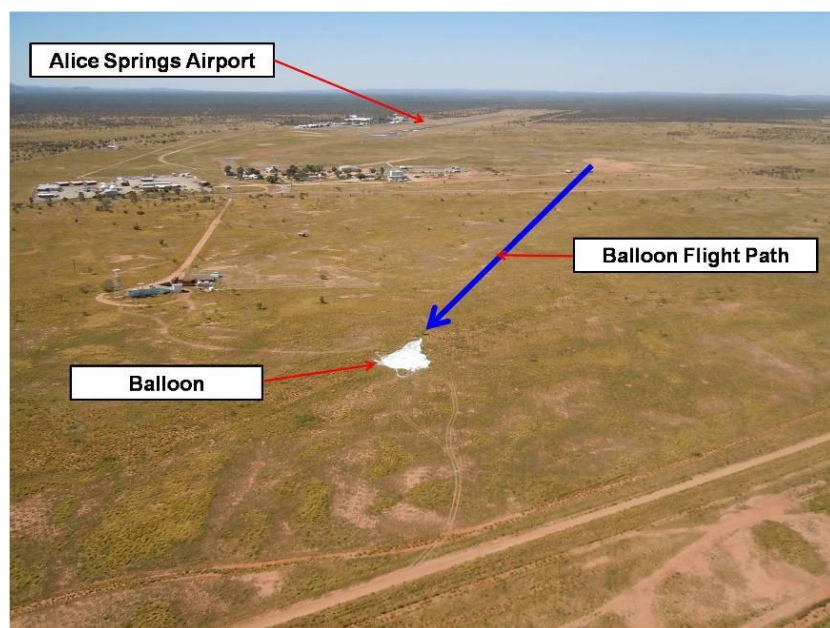
Figure 28. Balloon Landing Location

**Key Event 49:** The parachute and flight train were fully on the ground by **PET=199 sec**. The balloon came to rest on the ground some time later about  $\frac{1}{4}$  miles downwind in a field outside the airport indicated in Figure 28.

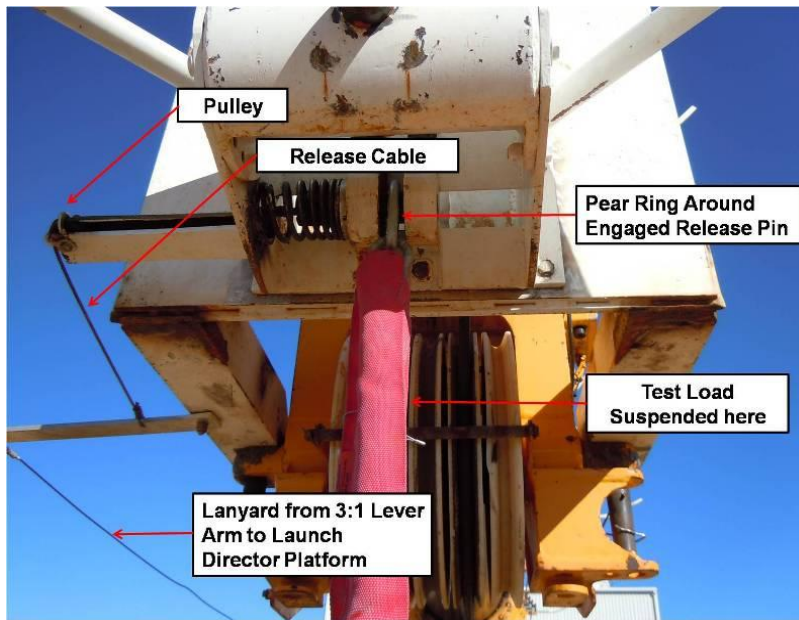
Figure 34. Field Test 1 Configuration

**Background**—Evidence indicated that there was an attempt to pull the lanyard cable that retracts the release pin during the launch attempt, but the lanyard did not release the pin as expected. The test was designed to determine the approximate lanyard force required to release the pin under several conditions. Since the release pin can be loaded through a ring via the safety restraint cables, a variety of loads was applied to a flight-identical pear ring using suspended loads. The test configuration is shown in Figure 34.

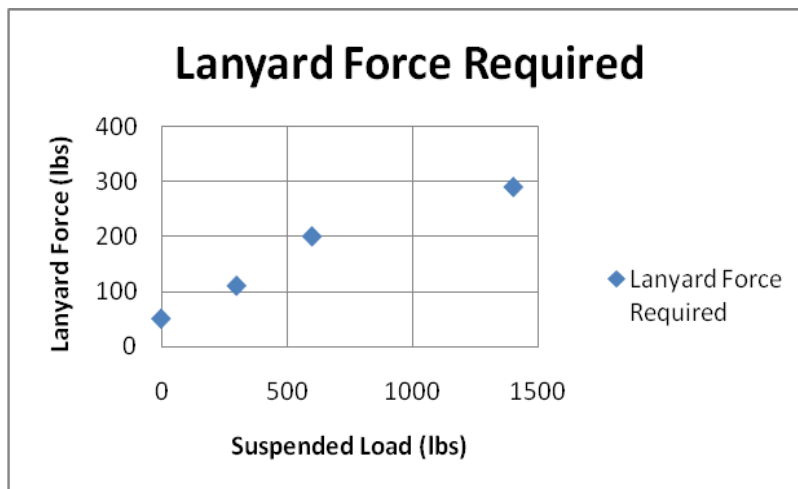
Figure 35. Lanyard Pull Force vs. Pear Ring Load

**Summary of Test**—A simple test was performed aimed at discovering the approximate forces required to pull the lanyard cable and retract the safety restraint cable release pin. The pear ring hanging from the release pin was subjected to a range of loading from zero to 1400 lb in order to determine the relationship between the pin loading and the load required to pull the release lanyard. The resulting lanyard forces ranged from approximately 50 lb at no load to 300 lb at 1400 lb load and are shown in Figure 35. The full test report is contained in Appendix C.

**Significance of the Test**—During the launch process, the LD is required to release the truck plate from the launch pin via the release lanyard. The required lanyard pull force increases with increase pin

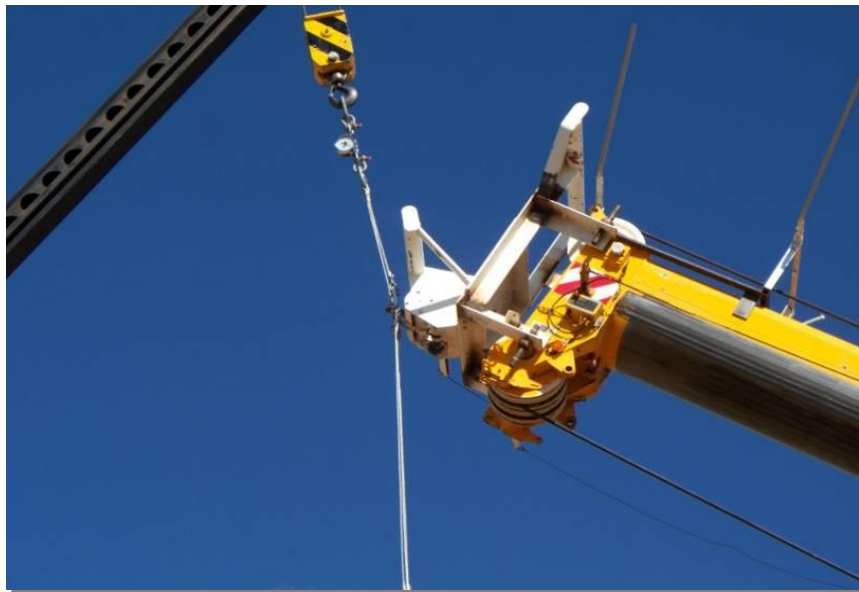
**Figure 36. Field Test 2 Configuration**

**Background**—Evidence indicated that there was an attempt to pull the lanyard cable that retracts the release pin during the launch attempt, but the lanyard did not release the pin as expected. This test was designed to determine the approximate lanyard force required to release the pin under loaded conditions. For this test, the balloon loads were simulated by applying loads with a crane through a cable harness and then through the truck plate. The configuration is shown in Figure 36.

**Summary of Test**—A simple set of tests was performed aimed at discovering the approximate forces required to pull the lanyard cable and retract the restraint cable release pin as a result of applied loads to the truck plate. The purpose of the test was to determine if loads applied to the truck plate (translated into loads on the pear ring and subsequently the restraint cable pin) through the flight train during launch operations would be sufficient to make release difficult for personnel. The truck plate was loaded in several representative ways to simulate potential launch loads. The applied test loads were limited in magnitude for two reasons: (1) To keep the crane and fitting loads well below the equipment

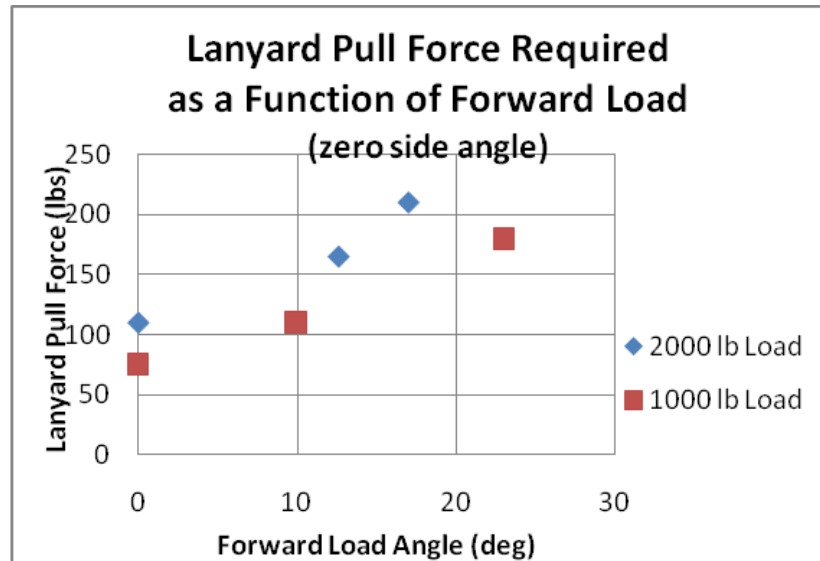
Figure 37. Lanyard Pull Force vs. Truck Plate Loading

**Significance of the Test**—During the launch process, the LD is required to release the truck plate from the launch pin via the release lanyard. The required lanyard pull force increases with increased pin loading. Resisting forces are created through friction with the pear ring and with the pillow block. The test was intended to determine the relationship of truck plate loading to the required lanyard pulling force.

**Test Conclusions**—The results of this test were generally as anticipated. Increasing loads through the truck plate increased the lanyard pull force. Increasing forward load angle increased the lanyard pull force. Increasing side angle increased the lanyard force only mildly, except for some combined load conditions where the lanyard force appeared to decrease.

Considering that the designed free lift (net lifting force on the launch pin) is about 985 lb, the lanyard force required for a balloon directly overhead would seem reasonable at about 80 pounds (in a no-wind condition). However, the tests indicate that with relatively small forward angles of 10 to 15 degrees (balloon ahead of the launch crane), the lanyard force could rise to 125 to 150 pounds. Adding loads created by the wind on the balloon could easily result in required lanyard pull forces well in excess of 200 pounds.

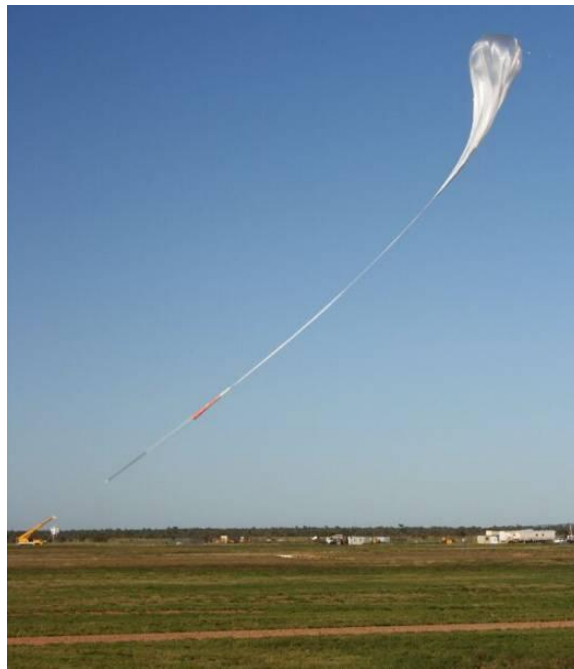
**Figure 39. Catenary When Launch Vehicle Arrives at Fence**

The system of structural elements and forces produces a complex catenary (the catenary is the characteristic curved shape typically produced by the combination of weight and tension forces on a suspended cable-like structure). The geometry is well represented in Figure 39, which shows the system upon arrival at the Airport fence.

This catenary system was modeled using two different methods, a multi-element, equilibrium, steady-state “shooting method” and a dynamic, elastic model that solves the accelerations of a lumped mass and spring system. Wind profiles were modeled using actual PiBal data. The two models agree well for compared static conditions. The results of the static and dynamic assessments were correlated with photo and video evidence and show agreement with catenary photo comparisons. Results predict considerable forces at the truck plate during the four key events.

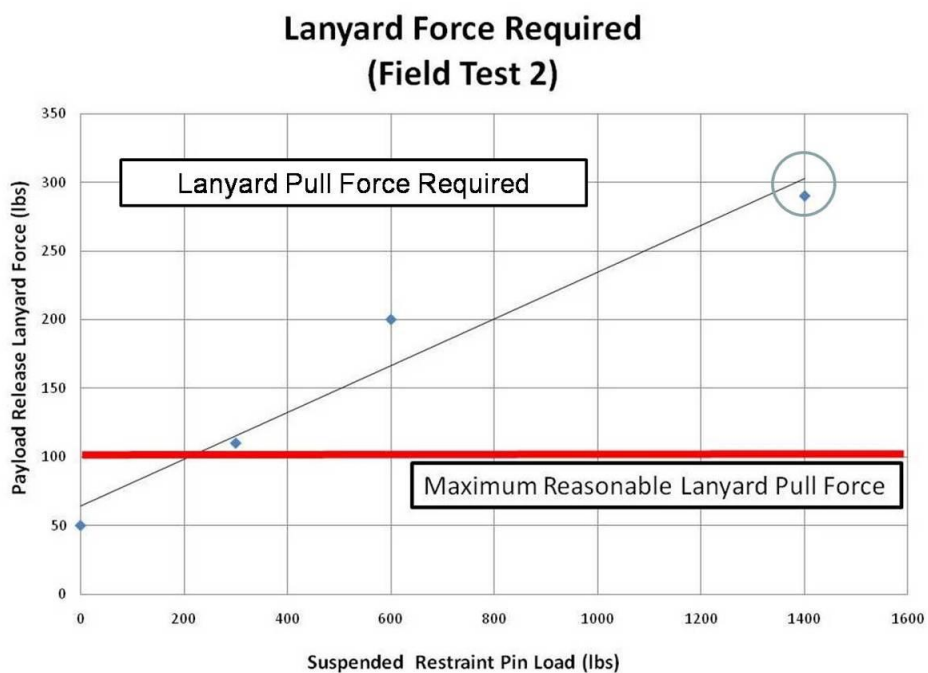
**Figure 41. Required Lanyard Pull Force at Time of Launch Attempt**

Using the data from Field Test 1, the resulting lanyard pull force would be predicted to be in excess of 300 lb (test data only covered up to 1400 lb suspended). Predicted loads on the launch mechanism and the resulting required lanyard pull force at the time of the launch attempt are shown in Figures 40 and 41.

Using the dynamic analysis and assuming the attempted lanyard actuation was before the vehicle began to slow, the lanyard force would be estimated as low as 200 lb. Therefore it is estimated that at the time of the launch attempts, the predicted lanyard pull force resulting from the balloon and flight train catenary was likely in the range of 200 to 300 lb. The required pull force during the launch

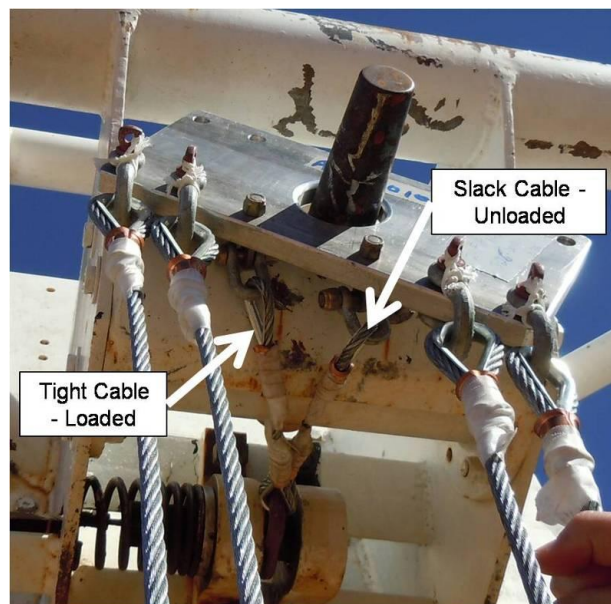
**Figure 44. Oblique Truck Plate Loading Off-Loads One Restraint Cable**

people, it is reasonable to suspect that the load was unevenly distributed between the cables due to the twisting action that is produced when the truck plate is loaded from the side. The MIB simulated the oblique loading condition on the truck plate during the site visit to Alice Springs in order to understand the behavior characteristics of the restraint cables. As seen in Figure 44, an oblique loading condition on the truck plate, such as the condition that existed at the time of restraint cable rupture, causes one restraint cable to be un-loaded. It is in a side-loaded condition that the cable assemblies ruptured.

Loads analysis predicts that the total load at the launch head produced by the balloon system was on the order of 10,000 to 12,000 lb at the time of release. This translates into about 7000 to 8000 lb in the restraint cables, which is at the rupture limit of the cables. Additionally, any pendulous motions would have the potential of adding to the maximum forces seen by the restraint cables. If most of the 8000 lb were applied to one cable, rupture would be expected in first one cable, then the other. The predicted load conditions at the time of restraint cable rupture are shown in Figure 45. Any other conditions caused by the twisting truck plate that produced combined loads (e.g., bending and tension) on the eyebolt elements would only have exacerbated the problem.

During the left turn maneuver of the launch crane, one restraint cable became off-loaded. The remaining restraint cable reacted the loads from the wind-driven balloon, which exceeded the cable's ultimate strength capability. One restraint cable ruptured, causing the unloaded cable to pick up the load. The second cable assembly also broke due to the loading condition. The load conditions and predictions of hardware behavior are consistent with hardware evidence collected in the field at Alice Springs.

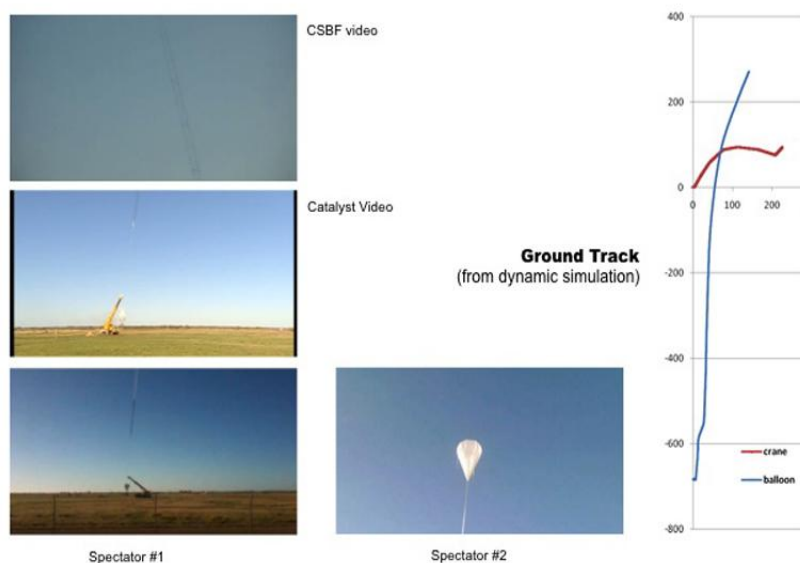
Figure 46. Video Evidence and Ground Tracks for Key Event 27

Key Event 27 PET = 44 seconds  
Launch crane turns left after sweeping right turn

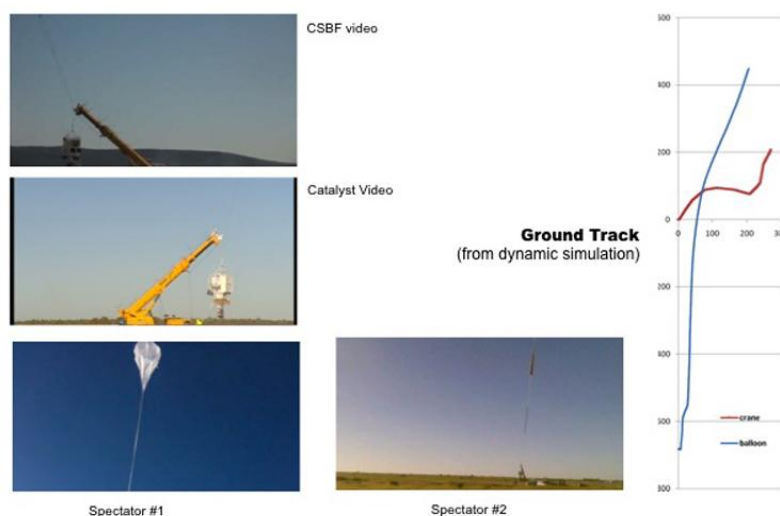
Figure 47: Video Evidence and Ground Tracks for Key Event 30

Key Event 30 PET = 62 seconds  
Launch crane slows down due to loss of traction

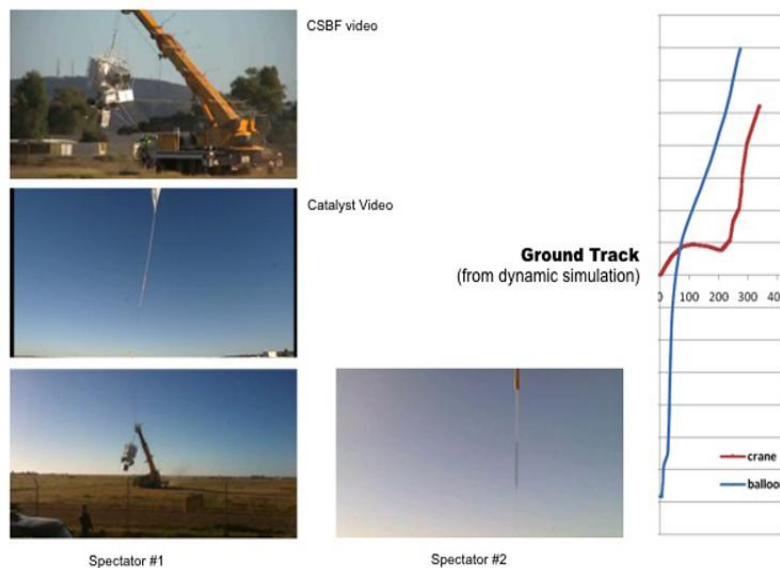
Figure 48. Video Evidence and Ground Tracks for Key Event 34

Key Event 34 PET = 86 seconds  
Launch crane slows down for launch attempt

4/29/2010	08:06:46 AM	87 sec.	Event 34	First visible launch attempted by pulling on the release cable without effect.
4/29/2010	08:06:48 AM	89 sec.	Event 35	Second visible launch attempted by pulling on the release cable without effect.
4/29/2010	08:06:50 AM	91 sec.	Event 36	Launch vehicle comes to a stop.
4/29/2010	08:06:52 AM	93 sec.	Event 37	Launch Director orders launch vehicle driver to go forward to catch the balloon.
4/29/2010	08:06:53 AM	94 sec.	Event 38	Launch vehicle lost traction while accelerating.
4/29/2010	08:07:04 AM	105 sec.	Event 39	Launch vehicle stops at airport perimeter fence.
4/29/2010	08:07:04 AM	105 sec.	Event 40	Due to spectators being in the downwind path and close proximity Launch Director cannot order flight termination.
4/29/2010	08:07:17 AM	118 sec.	Event 41	Launch vehicle starts moving in reverse.
4/29/2010	08:07:47 AM	148 sec.	Event 42	Launch vehicle loses traction in soft dirt and cannot continue in reverse.

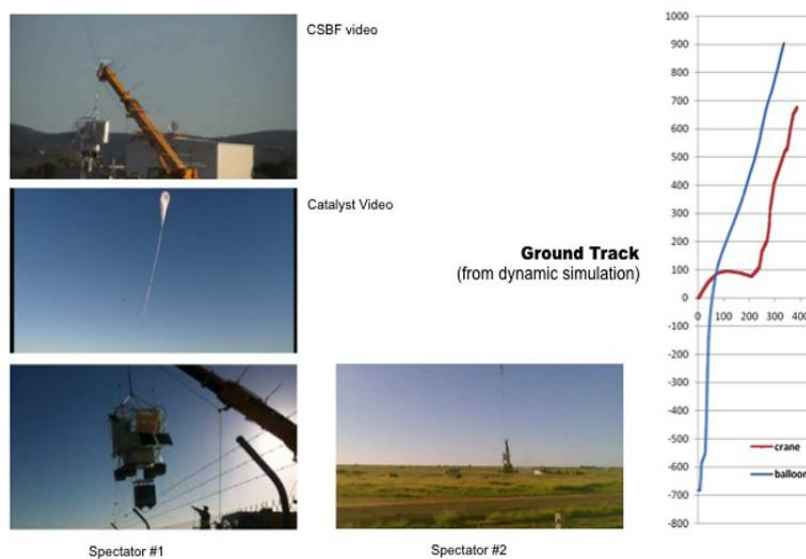
Figure 49. Video Evidence and Ground Tracks for Key Event 39

Key Event 39 PET = 105 seconds  
Launch crane stops at Airport perimeter fence

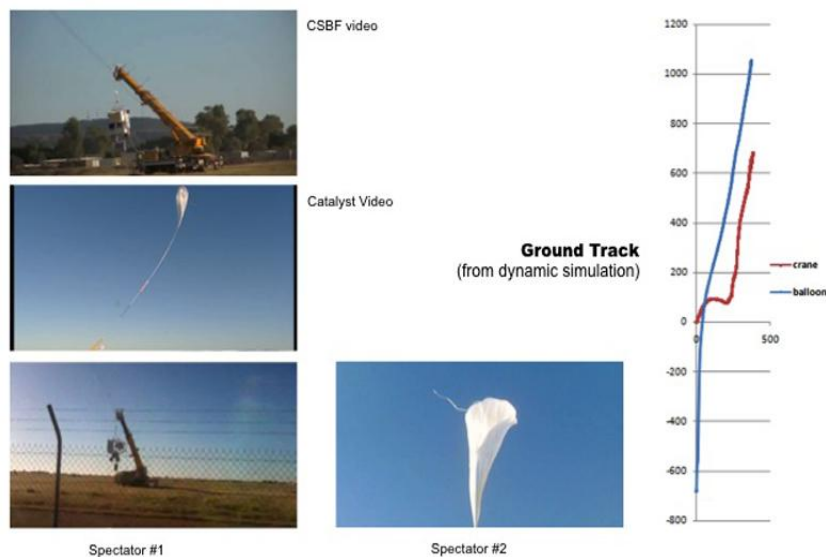
Figure 50. Video Evidence and Ground Tracks for Key Event 43

Key Event 43 PET = 150 seconds  
Launch crane starts left turn after backing up

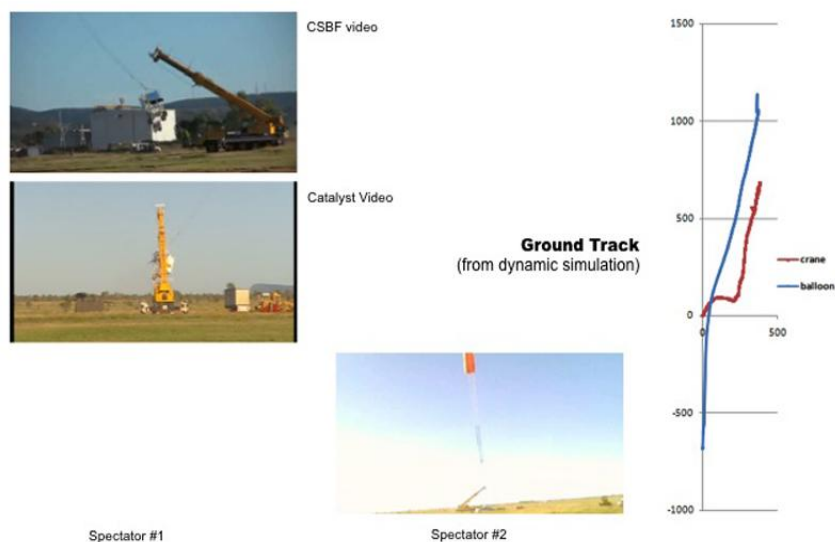
Figure 51. Video Evidence and Ground Tracks for Key Event 45

Key Event 45 PET = 171 seconds  
NCT payload inadvertently separates from launch  
crane

4/29/2010	08:07:49 AM	150 sec.	Event 43	Launch Director orders the launch vehicle driver to pull forward making a left 90-degree turn.
4/29/2010	08:08:10 AM	171 sec.	Event 44	Safety restraint cables snapped.
4/29/2010	08:08:10 AM	171 sec.	Event 45	Uncontrolled release of the Nuclear Compton Telescope payload resulting in the payload impacting the ground, then a privately owned vehicle and nearly causing injury or death to public spectators. (Undesired Outcome)
4/29/2010	08:08:10 AM	171 sec.	Event 46	Abort called.
4/29/2010	08:08:16 AM	177 sec.	Event 47	Payload impacted the POV
4/29/2010	08:08:19 AM	180 sec.	Event 48	Abort accomplished.
4/29/2010	08:08:38 AM	199 sec.	Event 49	Parachute and flight train come to rest on ground
4/29/2010	08:10:00 AM	281 sec.	Event 50	Final PIBAL run accomplished after abort.

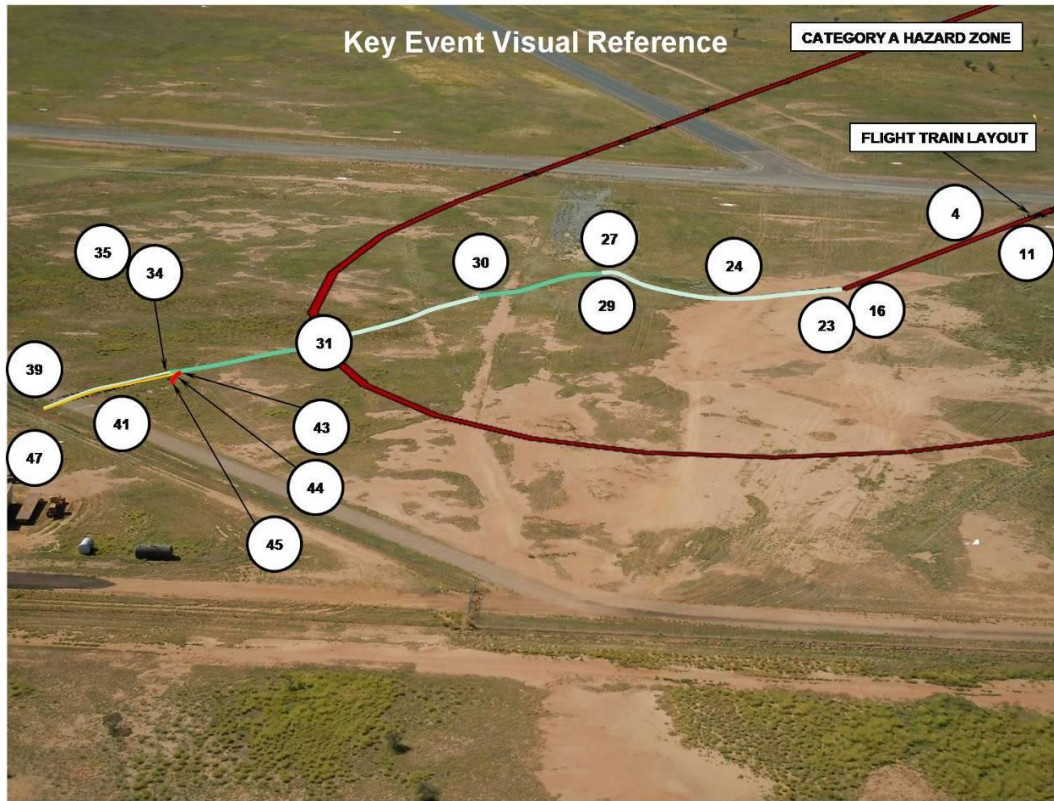
Figure 52. Significant Key Event Visual Reference

While gathering data, the MIB developed and maintained a timeline of the events leading up to the mishap. This timeline initially started with the events immediately prior to the mishap. As the RCA progressed, the time line expanded further back in time to include events that were related to the intermediate causes and the proximate causes. The MIB time-synchronized all six video evidence recordings to help determine the PET of events following spool release. The detailed timeline is shown below in Table 3. Significant key events from this timeline are shown overlaid with the launch vehicle's GPS track in Figure 52.

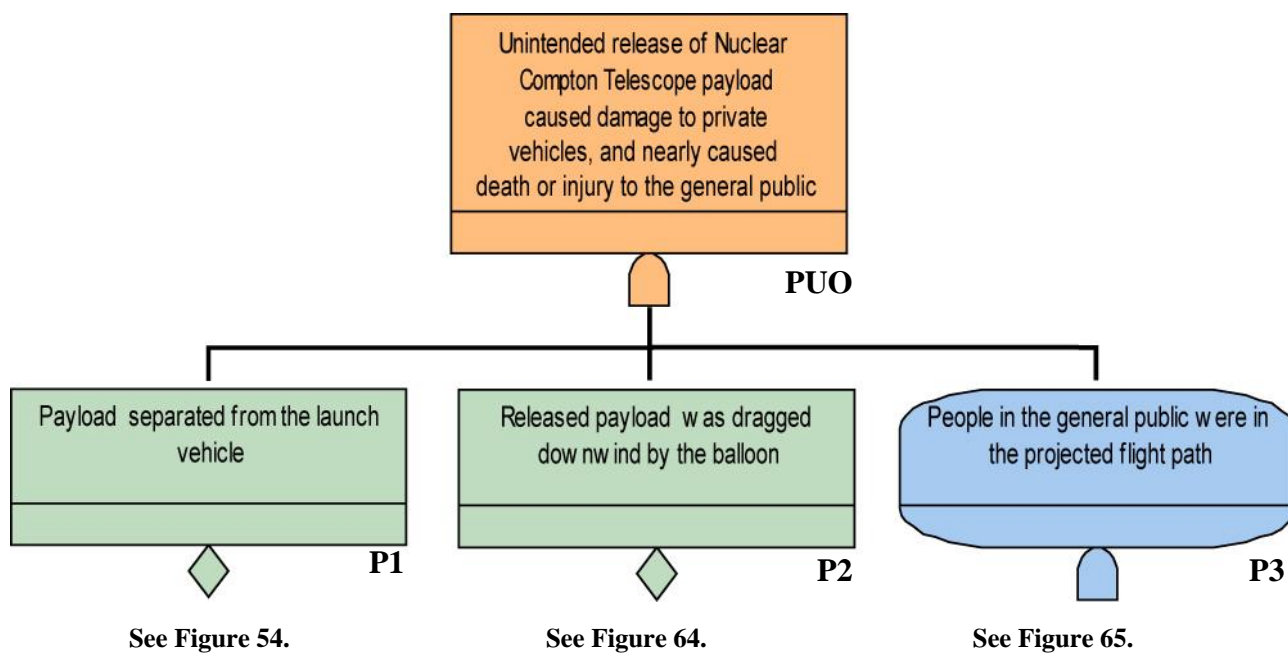
Figure 53. Primary Undesired Outcome and Proximate Causes

The MIB identified three Proximate Causes that resulted in the Primary Undesired Outcome: **Unintended release of Nuclear Compton Telescope payload caused damage to private vehicles, and nearly caused death or injury to the general public (PUO).** Figure 53 shows the Primary Undesired Outcome and Proximate Causes.

The Proximate Causes are the events that occurred, including any condition(s) that existed immediately before the Primary Undesired Outcome that directly resulted in the occurrence of the Primary Undesired Outcome and, if eliminated or modified, would have prevented the Primary Undesired Outcome. These are also known as the direct causes. First, **the payload separated from the launch vehicle (P1)**, then **the released payload was dragged downwind by the balloon (P2)**, and the condition existed that **people in the general public were in the projected flight path (P3).**

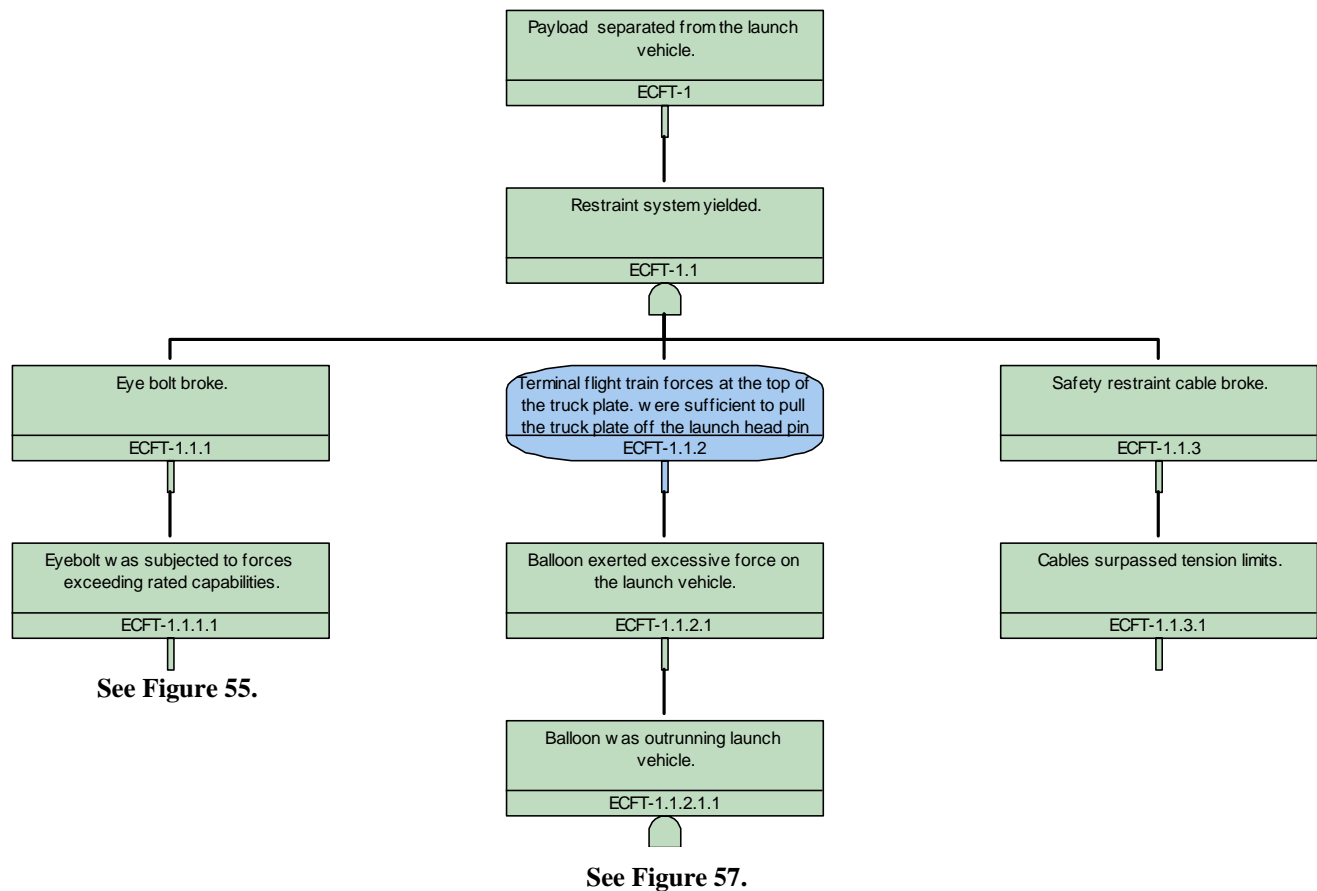
**Figure 54. Payload Separated From Launch Vehicle**

Per video and witness interview, the payload unexpectedly separated from the launch vehicle after several vehicle maneuvers at Alice Springs Airport. The factors leading to the payload separation are as follows:

1. The balloon exerted excessive force on the launch vehicle. Based on video evidence, the distance (projected on the ground) between the balloon and the launch vehicle caused a significant horizontal force on the launch vehicle.

- a. According to video evidence, the balloon was outrunning the launch vehicle and the challenge to catch it was becoming too great.
- C. Safety restraint cable broke. This was verified by inspection of the impounded hardware. The safety restraint cable was used to secure the payload to the launch vehicle. Based on video evidence, test results and analysis, the board determined that the tension in the cable surpassed the cable's rated limits and subsequently the cable broke. The causes follow the same line of reasoning for item A. above and will not be repeated in the report.

Video evidence indicates that the payload, having been separated from the launch vehicle after the events described in Figure 54, was dragged along the ground, pulled by the balloon under and in the direction of the prevailing wind.

- B. Balloon exerted excessive force on the launch vehicle. The balloon being significantly ahead of the vehicle caused a large horizontal force on the launch vehicle. This was evident from video and analysis. The logic continues the flow in the middle branch of Figure 54.

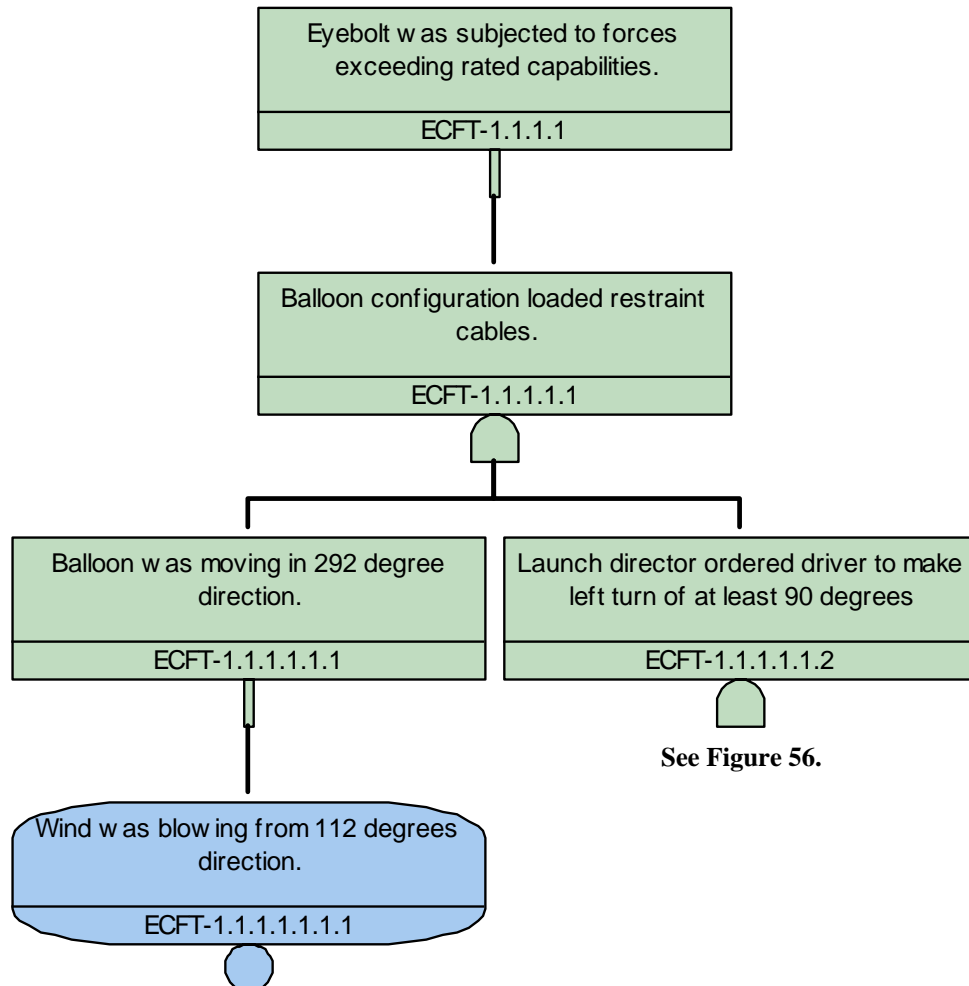
Figure 55. Eyebolt Was Subjected to Forces Exceeding Rated Capabilities

- A. According to video evidence, testing, and analysis, the balloon configuration loaded the restraint cables. The relative position of the balloon to the launch vehicle placed a significant tensile load on the restraint cables that secured the payload to the launch vehicle.
1. According to written meteorology records, the balloon was moving in a 292-degree direction, relative to magnetic north, along with the direction of the wind.
  2. According to video evidence and interview, the launch director ordered the driver to make a left turn of at least 90 degrees. This motion directly opposed the balloon motion, maximizing the stress applied to the system used to secure the payload to the launch vehicle.
    - a. According to meteorology records, the wind was blowing from the 112 degree direction.

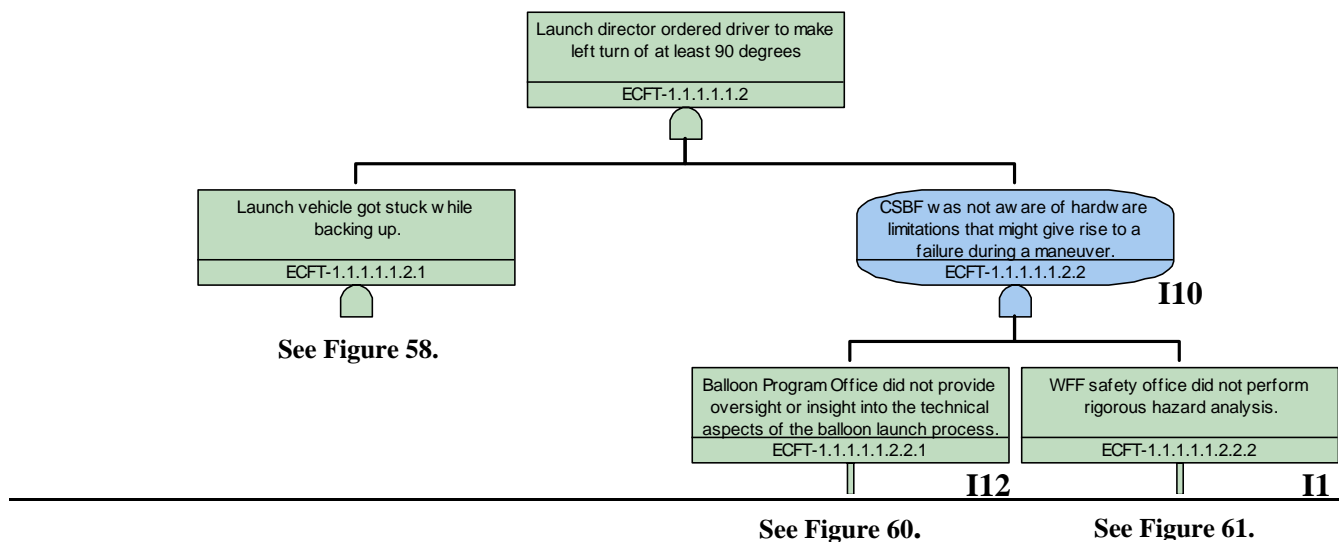
**Figure 56. Launch Director Ordered Driver to Make a Left Turn of at Least 90 Degrees**

- A. Video evidence and interviews indicated that the launch vehicle got stuck while backing up. The wind and terrain prevented the vehicle from moving a safe distance from the spectators.
- B. Based on interviews and the lack of specific reference in the hardware documentation evidence received by the board, it became apparent that CSBF was not aware of hardware limitations that might give rise to failure during a maneuver. There were no limitations put on what types or durations of maneuvers under what wind or terrain conditions might cause the hardware to exceed its strength limitations. **Intermediate Cause I10**
1. Interview evidence indicated that the BPO did not provide oversight or insight into the technical aspects of the balloon launch process. The technical implementation is left to CSBF through the performance-based contract. **Intermediate Cause I12**

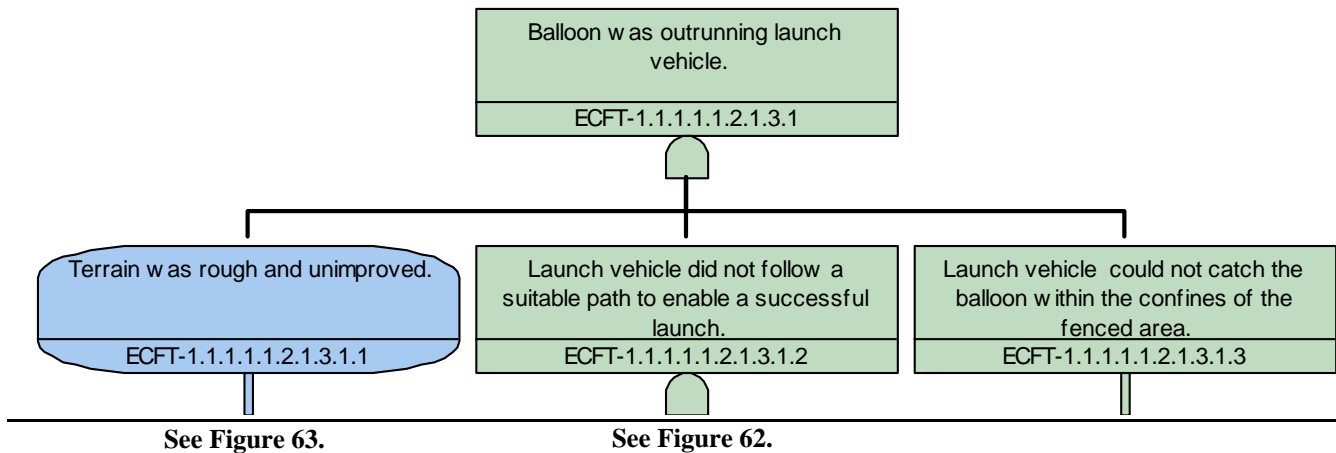
**Figure 57. Balloon Was Outrunning the Launch Vehicle**

- A. The terrain was rough and unimproved. Interviews and site inspection indicate that the terrain was loose and sandy in spots, not an ideal setting for traction.
- B. The launch vehicle did not follow a suitable path to enable a successful launch. Video evidence indicates that the vehicle took inefficient and, in some cases, overly sharp turns to catch the balloon.
- C. Launch vehicle could not catch the balloon within the confines of the fenced area. This is due to the fact that the flight train layout (direction, in particular) restricted the range of motion for the launch vehicle (block not shown). This is indicated from video evidence.

- A. The balloon was outrunning the launch vehicle. The balloon was ahead and getting further ahead and more and more challenging to catch.
1. Launch vehicle did not follow a suitable path to enable a successful launch. Some of the turns taken by the launch vehicle caused the vehicle to lose ground on catching the balloon. This is evident from interviews and video.
  2. Terrain was rough and unimproved. Logic in Figure 63 follows and is not repeated here.
- Intermediate Cause I8.**
3. The launch vehicle could not catch the balloon within the confines of the fenced area. The combination of speed limitations of the crane and the limited travel range of the vehicle due to the layout of the flight train and limited area prevented the launch vehicle from being able to catch the balloon (block not shown). This is evident from videos and documentation.

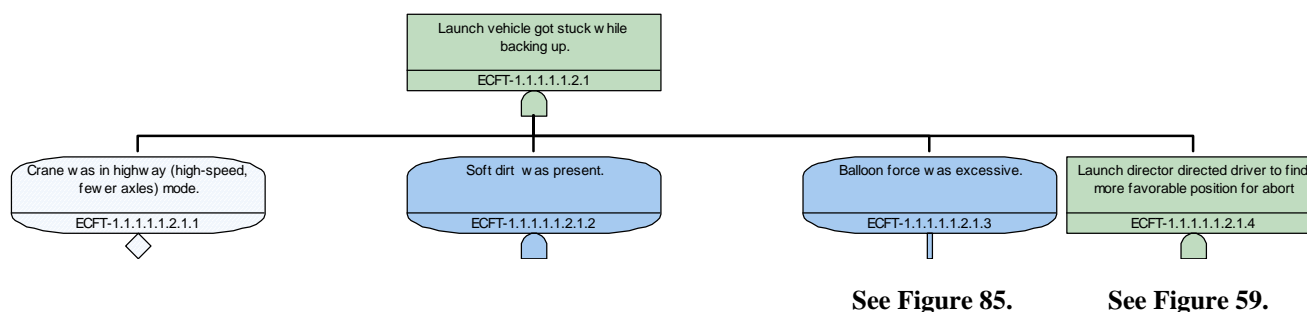
**Figure 58. Launch Vehicle Got Stuck While Backing Up**

- A. The crane was in highway (high-speed, two-axle) mode, according to information provided from the BPO. This enabled higher speed motion with a better chance to catch the balloon while it was ahead, but there was accordingly less traction when really needed. Strictly speaking, this is a contributing factor, but the fact is that whatever mode the crane was in would have been a contributing factor and there was no determination by the board that any possible mode would have made more of a contribution to this mishap.

- B. Soft dirt was present, based on on-site inspection and interviews. This permitted less traction when there was high tension from the balloon. The rest of this branch is not shown, but the logic leads to a combination of recent rainy weather and Root Cause R6.

- C. Balloon force was excessive. The vehicle could not overcome the force with the traction available. This was based on analysis and simulation.
- D. Launch director directed driver to find more favorable position for abort, based on interview and video evidence. He did not want to abort with people ahead, in-line with the balloon.

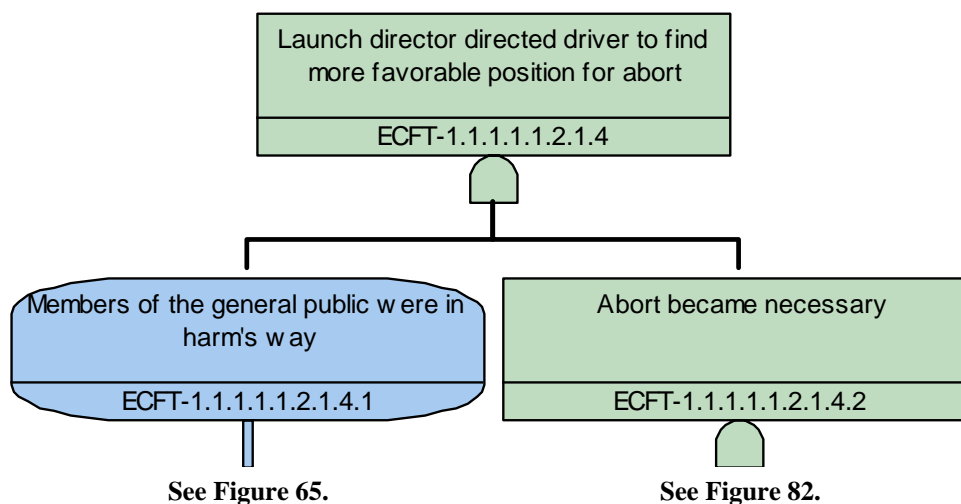
**Figure 59. Launch Director Directed Driver to Find a More Favorable Position for Abort**

- A. People in the general public were in harm's way. People behind the fence were at risk due to the hazard of falling balloon and flight train hardware.
- B. Abort became necessary. It became clear that based on all of the factors and previous attempts to launch that there would not likely be a chance for successful launch.
